# DRAFT STUDY REPORT

## BAR MILLS HYDROELECTRIC PROJECT

FERC No. 2194

**Kleinschmidt Associates**

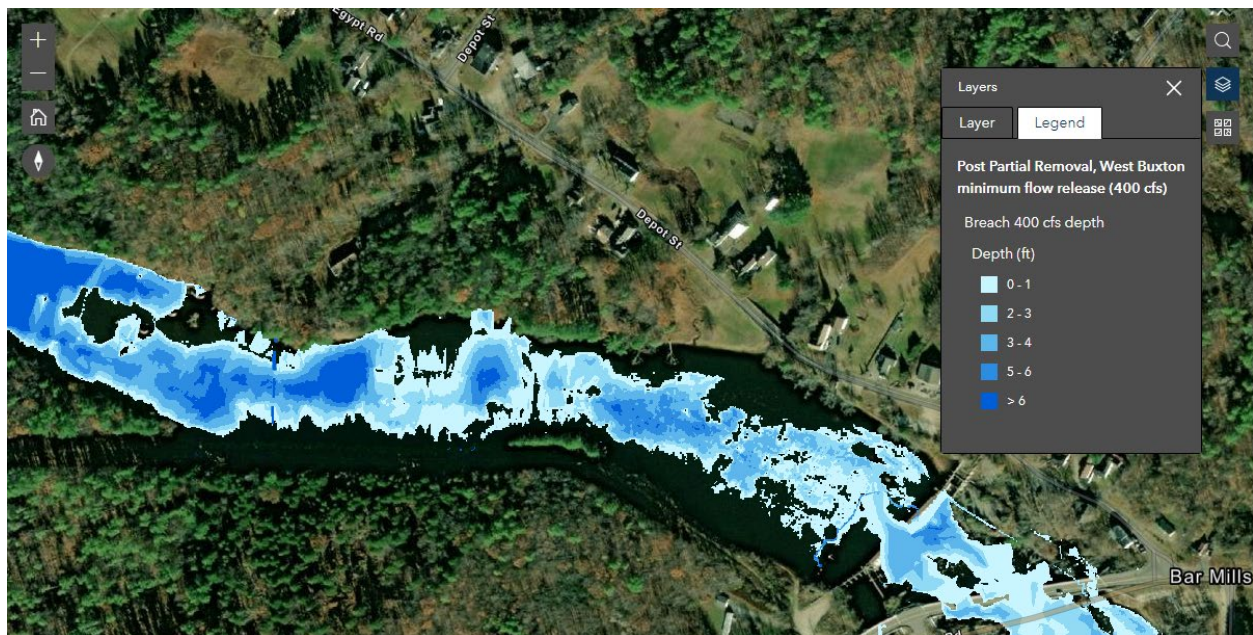
**Photo 5-1 Reach Between Bar Mills Dam and Upstream Hydraulic Control**

Based upon hydraulic modeling of water depths developed from field collection of bathymetry data in 2021, it was determined that under partial and full spillway removal conditions, the presence of a hydraulic control approximately 2,200 feet upstream of the Bar Mills Dam is likely to limit the most significant change in water surface elevations to

the area between the dam and the hydraulic control (Photo 5-1), which was determined to be an appropriate area of study relative to sedimentation.

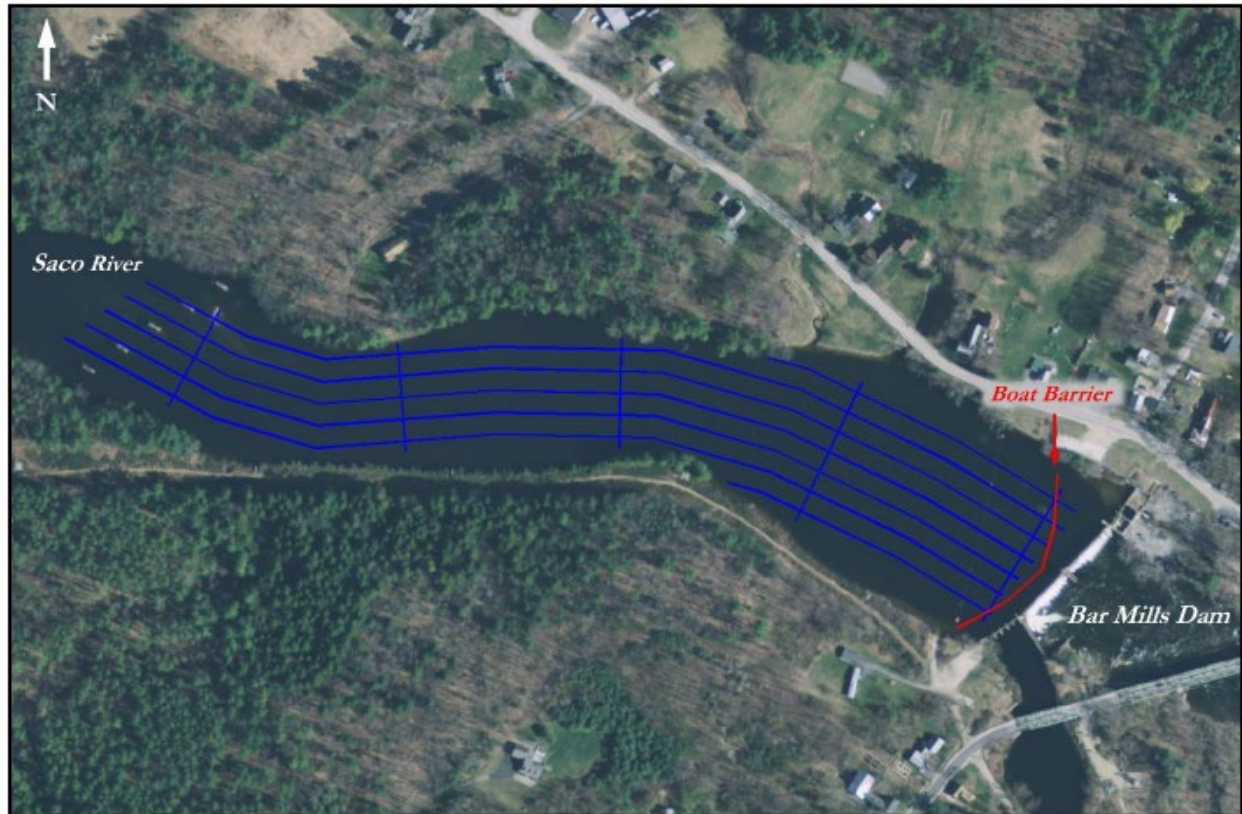
**Photo 5-2 Subbottom Profiling Tracks**

The area was surveyed utilizing a boat outfitted with high resolution depth sounding equipment to conduct sonar based subbottom profiling of the reach extending upstream from the Bar Mills dam boater safety barrier along 500 foot spaced tracks (Photo 5-2). Manual push probing was conducted in shallow locations (depths of less than 10 feet) as a ground truthing technique. Due to safety constraints, subbottom profiling could not be conducted in the area between the boater safety barrier and the dam but the barrier was slacked to maximize the profiling coverage area to within approximately 50-100 feet of the upstream face of the dam. Underwater imagery was collected from the dam to qualitatively assess the sedimentation immediately upstream of the dam.

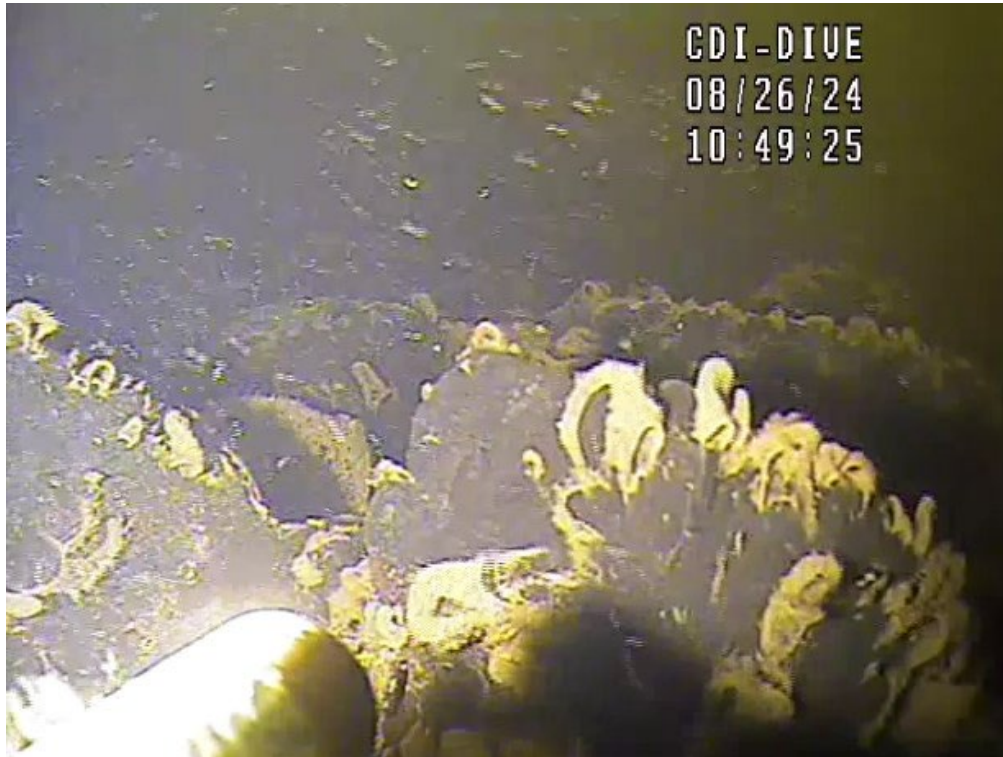
**Photo 5-3 Underwater Imagery Immediately Upstream of Bar Mills Dam**

Underwater imagery immediately upstream of the face of Bar Mills dam showed that very little sediment is accumulated in this area, which is dominated by large boulders, cobble, and woody debris (Photo 5-3 and Photo 5-4). Due to the limited sedimentation found through subbottom profiling and underwater imagery at the face of the dam, TRC conducted limited sampling on the impoundment shoreline margins upstream of the dam, in the canal, and downstream of the former Fibre Mill intake structure (Figure 5-1). This included a sediment sample in the area near the entrance to the former penstocks of the mill dam in consideration of comments provided by the Town of Buxton in a letter dated July 11, 2024.

Due to access safety constraints, OSI was unable to access the area immediately upstream of the Bar Mills spillway. In order to characterize sediment accumulation and composition in this area, BPHA collected underwater video/imagery utilizing a pole mounted video camera to access the area at the upstream face of the dam. Imagery documented little to no sediment accumulation at the upstream face of the dam with primarily cobble/boulder substrate and woody debris (Photo 5-3 and Photo 5-4).

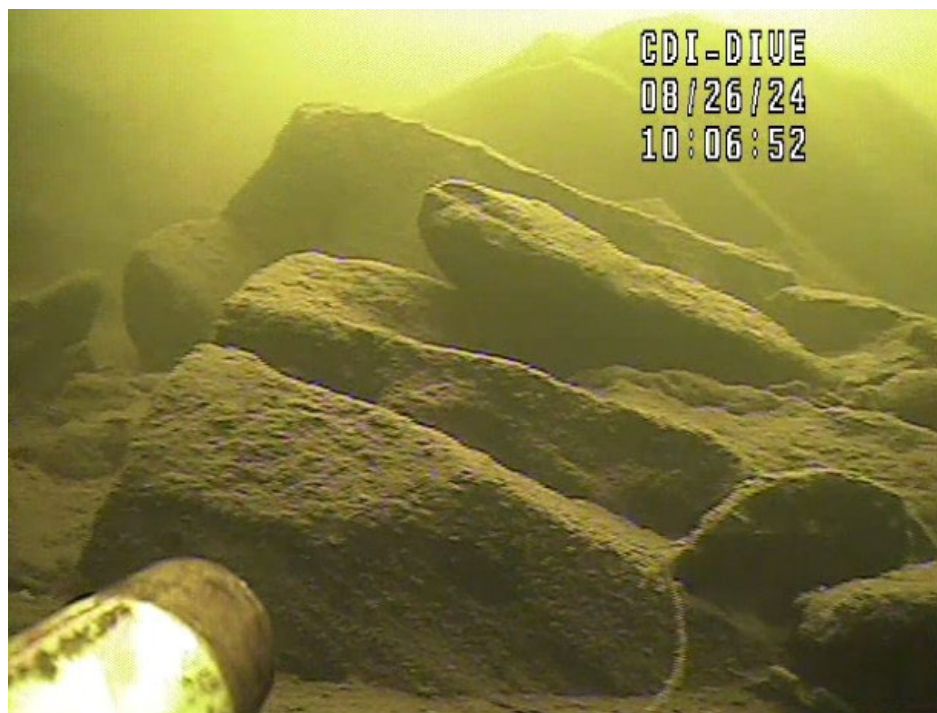
**Photo 5-4 Boulders and Debris Observed Underwater at the Upstream Face of Bar Mills Dam**

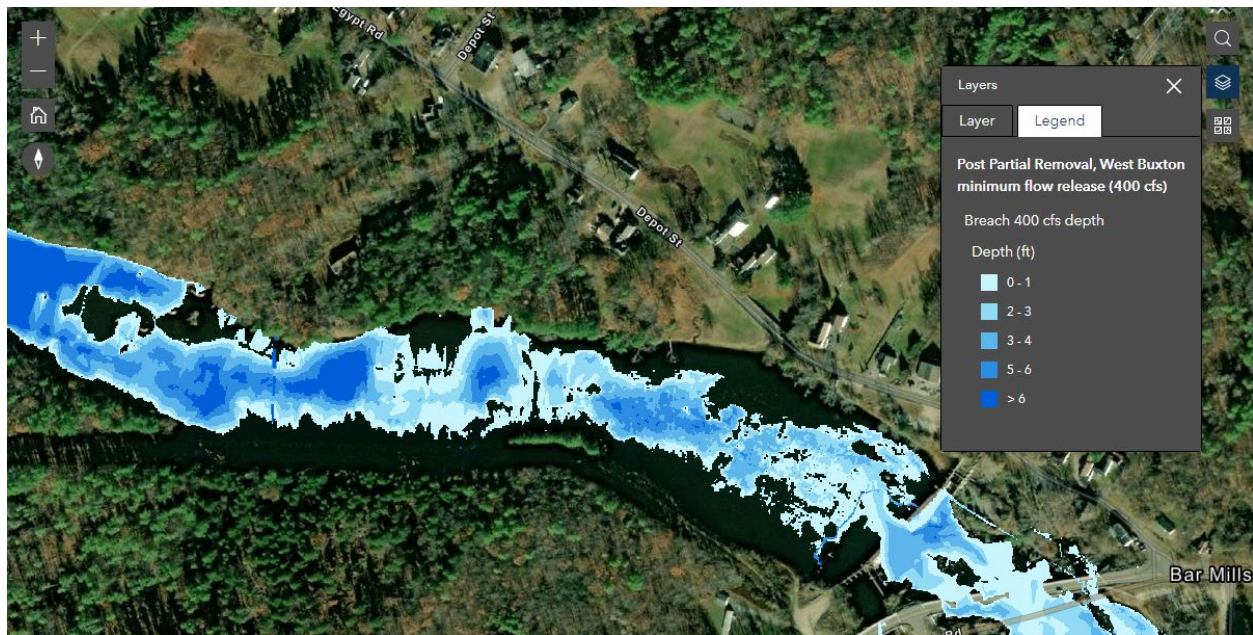
**Figure 6-1 Reach Between Bar Mills Dam and Upstream Hydraulic Control at Modeled River Flow of 400 cfs Under Partial Spillway Removal**

Based upon hydraulic modeling of water depths developed from field collection of bathymetry data in 2021, it is anticipated that under partial dam removal conditions, the presence of a hydraulic control approximately 2,200 feet upstream of the Bar Mills Dam is likely to limit the most significant change in water surface elevations to the area between the dam and the hydraulic control (Figure 6-1).

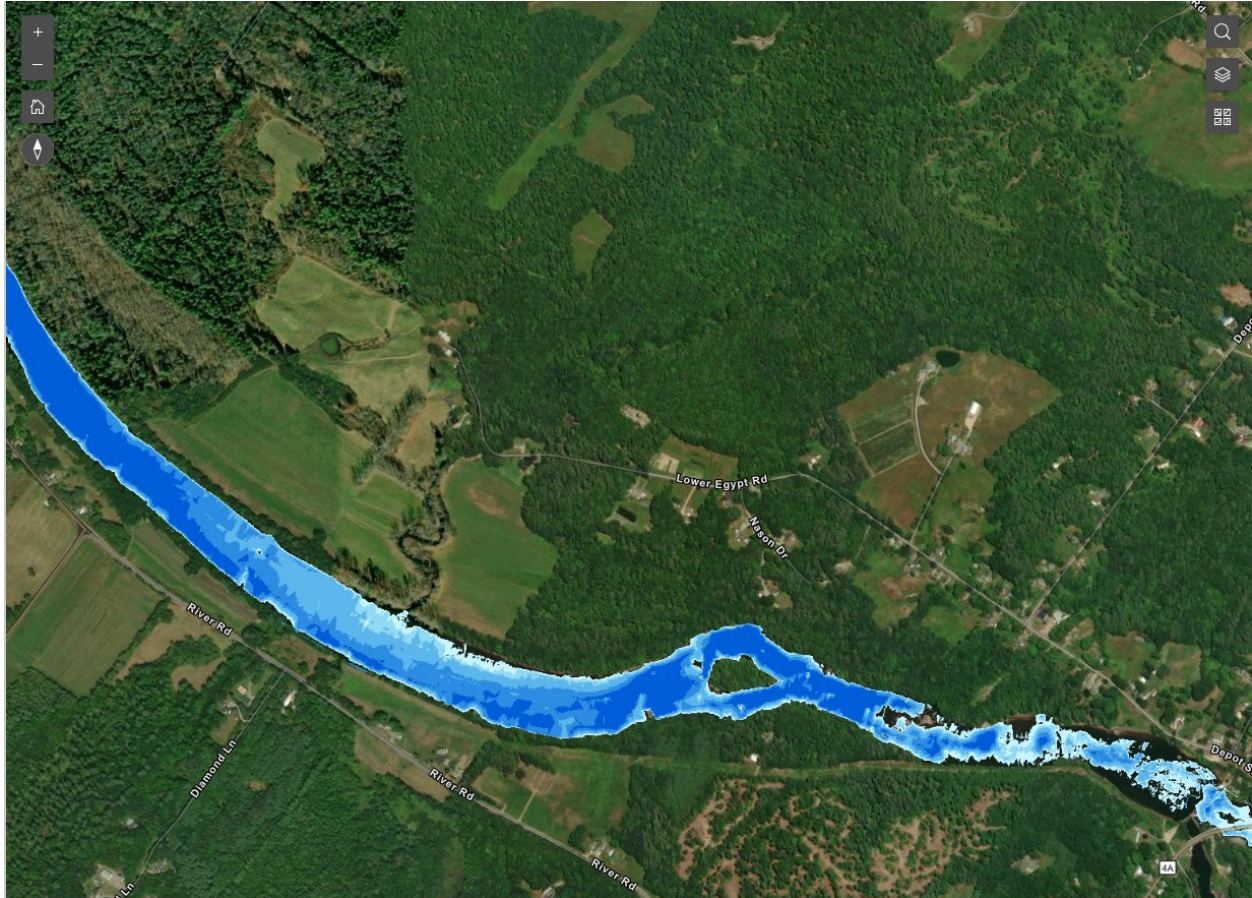
**Figure 6-10 Reach Upstream of Mills Dam and Hydraulic Control at Modeled River Flow of 400 cfs Under Full Removal Conditions**

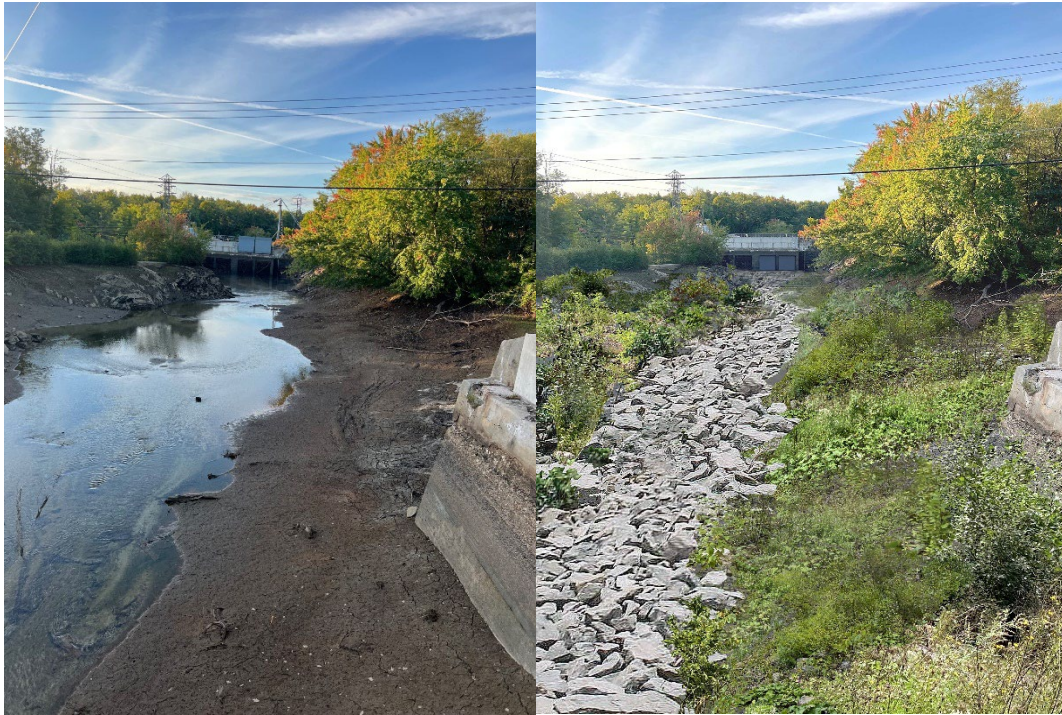
**Photo 11-12 Existing and Rendering of Power Canal**

An additional rendering was also developed looking down the power canal towards the powerhouse as compared to current conditions under dewatering, Photo 11-12. The primary differences illustrate a permanently dewatered condition for the canal and removal of the transmission tower and crane structure on the powerhouse.
